Evaluation of the Debris Throw from the 1992 Explosion in the Steingletscher Installation in Switzerland

Peter O. Kummer
dipl. Ing. HTL/SIA, EUR ING
BIENZ, KUMMER & PARTNER LTD, Langägertenstrasse 6
CH-8125 ZOLLIKERBERG, SWITZERLAND
Tel: int 41 1 391 27 37 FAX: int 41 1 391 27 50

On 2 November 1992 a detonation with an approximate force of 225 tons of TNT happened in the Steingletscher ammunition and explosives storage installation in Switzerland. Six people lost their lives in this accident. The installation was destroyed completely, the rock cover above the underground chamber broke off and rock as well as concrete pieces were thrown over a wide range into the surroundings.

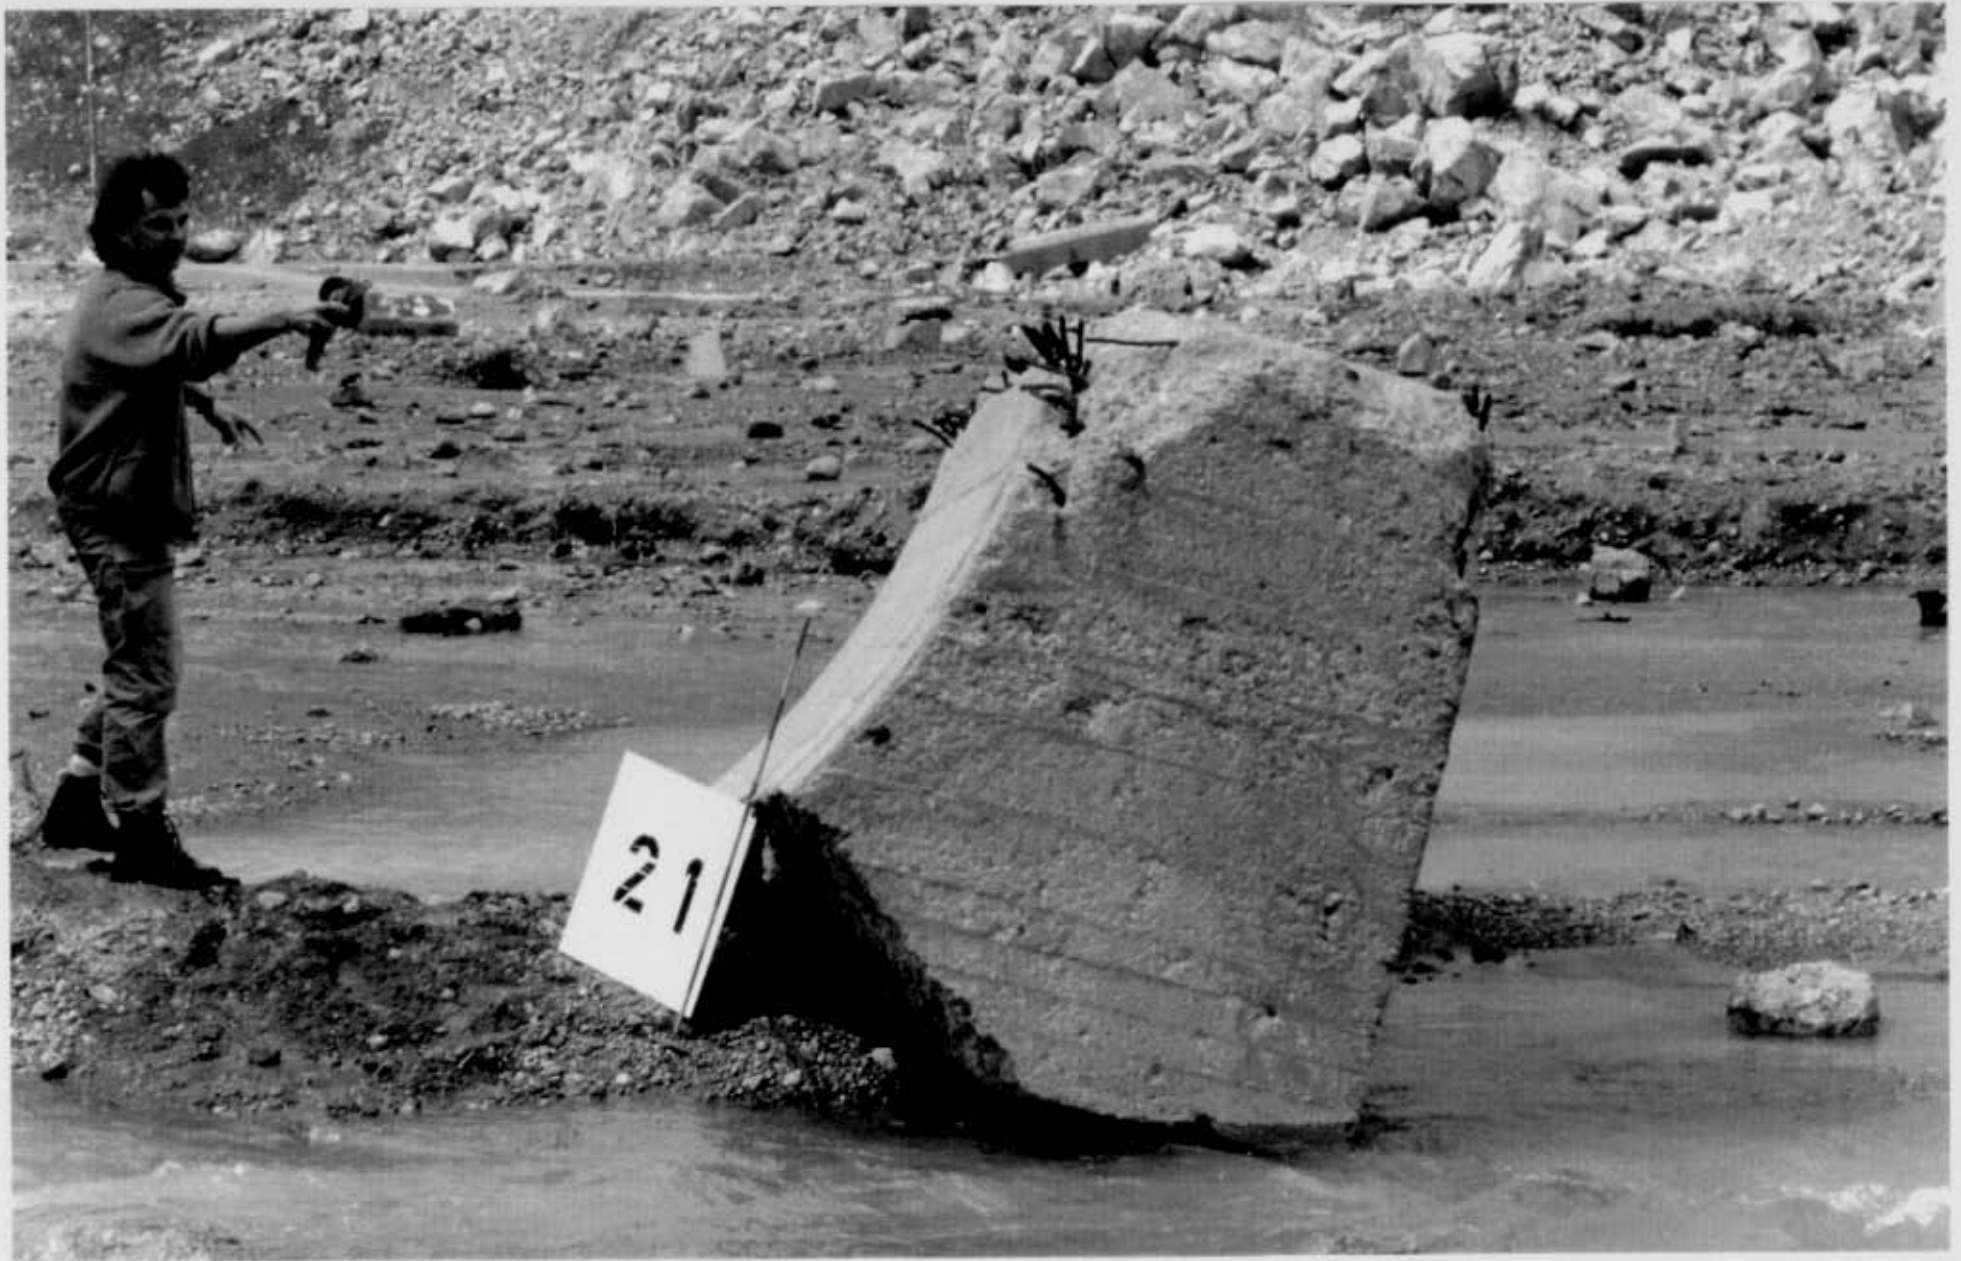
Figure 7

Concrete Block from Entrance Building
Weight 15 tons, 370 m from Original Place

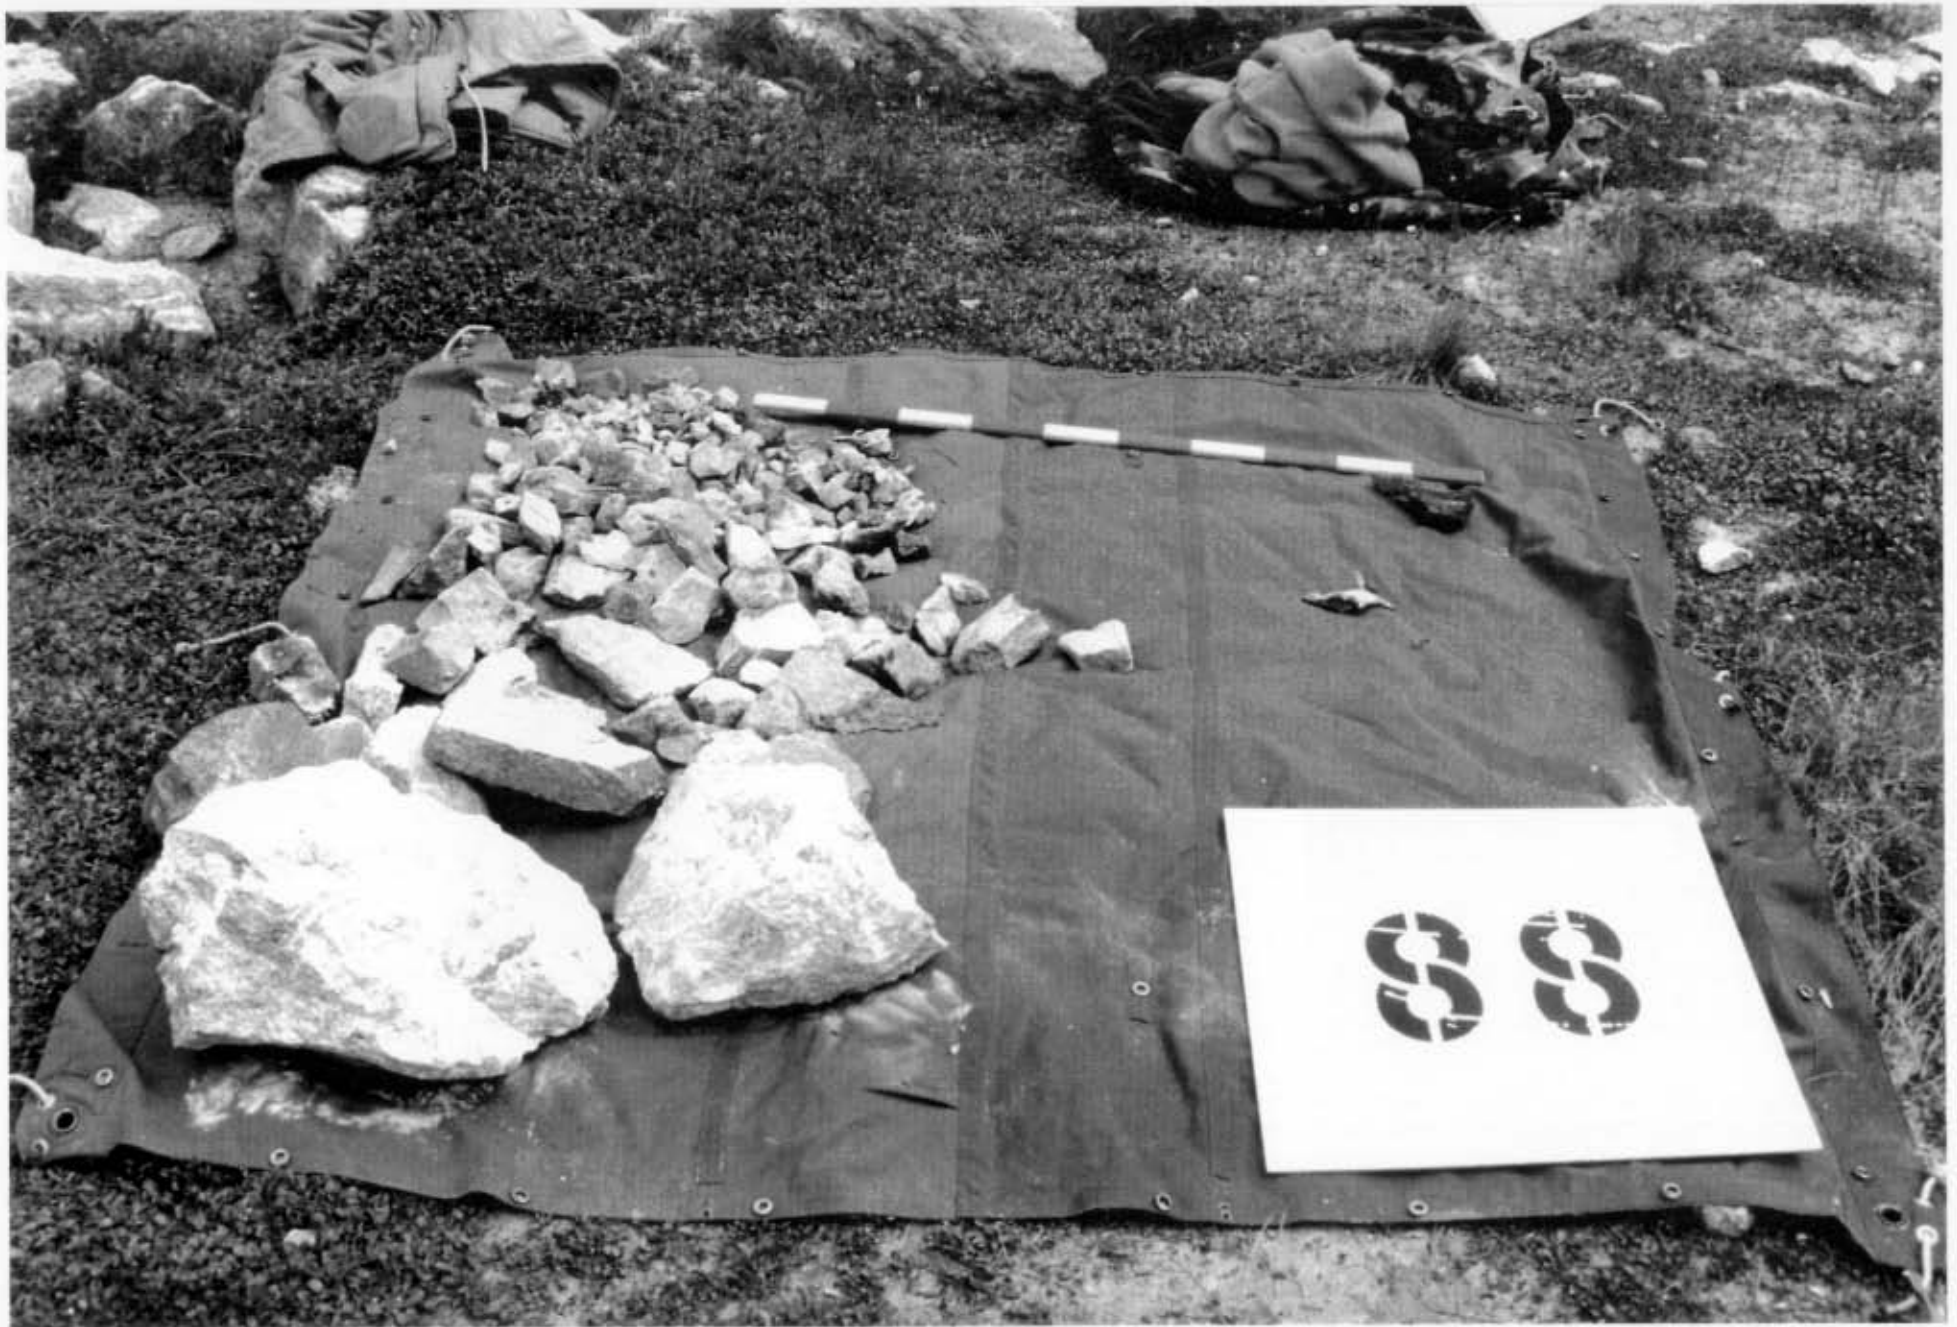
3. At last, all debris were collected, sorted out for different materials (rock, concrete, metal parts etc.) and according to their seize. Figure 10 shows an example. The debris were counted and weighted. Back in the office, for each debris field a data sheet showing all details was elaborated and, as a first step of the evaluation, the debris density in kg/m² was defined (fig. 11). Figure 12 gives an overview of the data of all debris fields.

Debris from a "Collection Area"
